ACTIVE BEACON COLLISION AVOIDANCE SYSTEM (BCAS) LOGIC PERFORMANCE DURING OPERATIONAL FLIGHT TESTS

R.A. TORNESE
A.L. MCFARLAND

The MITRE Corporation
McLean, Virginia 22102

JANUARY 1981

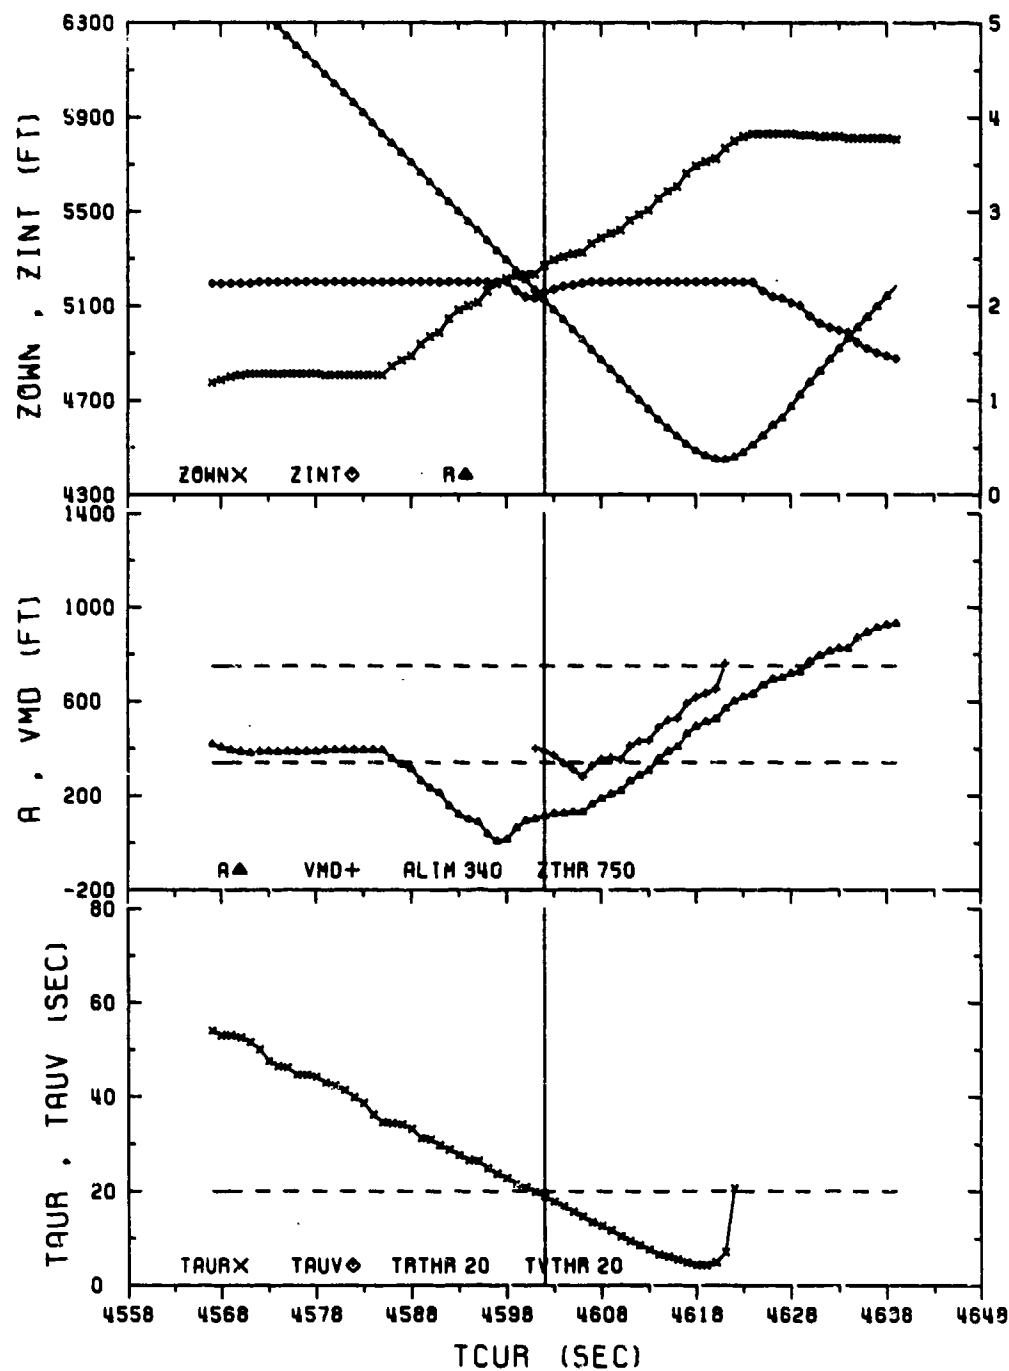
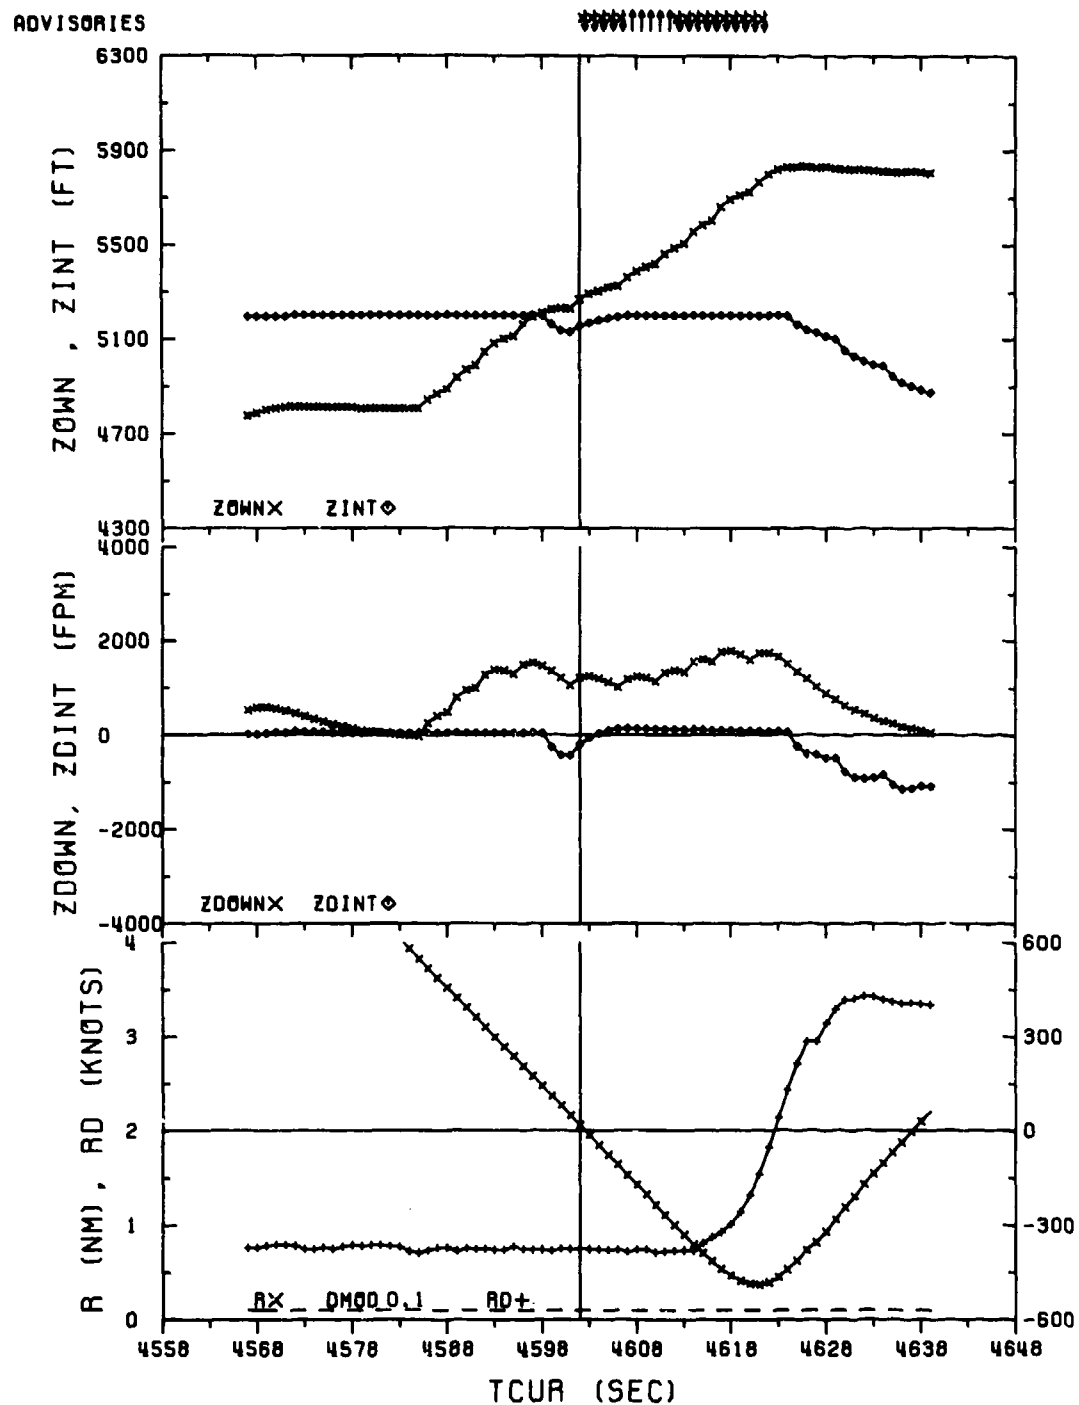
FIGURE 4-18
SEPARATION, TAU PLOTS FOR ENCOUNTER 8 AT SALT LAKE CITY

FIGURE 4-19
SEPARATION, RATE PLOTS FOR ENCOUNTER 8 AT SALT LAKE CITY

A Mode C excursion in the intruder's Mode C reports, and the resulting negative vertical tracked velocity, caused the advisory to start as a negative, rather than as a positive. The oscillatory nature of the vertical velocity around zero caused the advisory to transition to positive. As the BCAS aircraft continued its climb, the advisory transitioned back to negative. It is evident from Figure 4-18 that VMD was only momentarily below the ALIM threshold. This was a grazing encounter, where VMD was near the threshold and small oscillations contributed to the advisory transitions. The pilot of the BCAS aircraft felt the advisory was useful in this situation. The sense of the advisory was clearly correct.

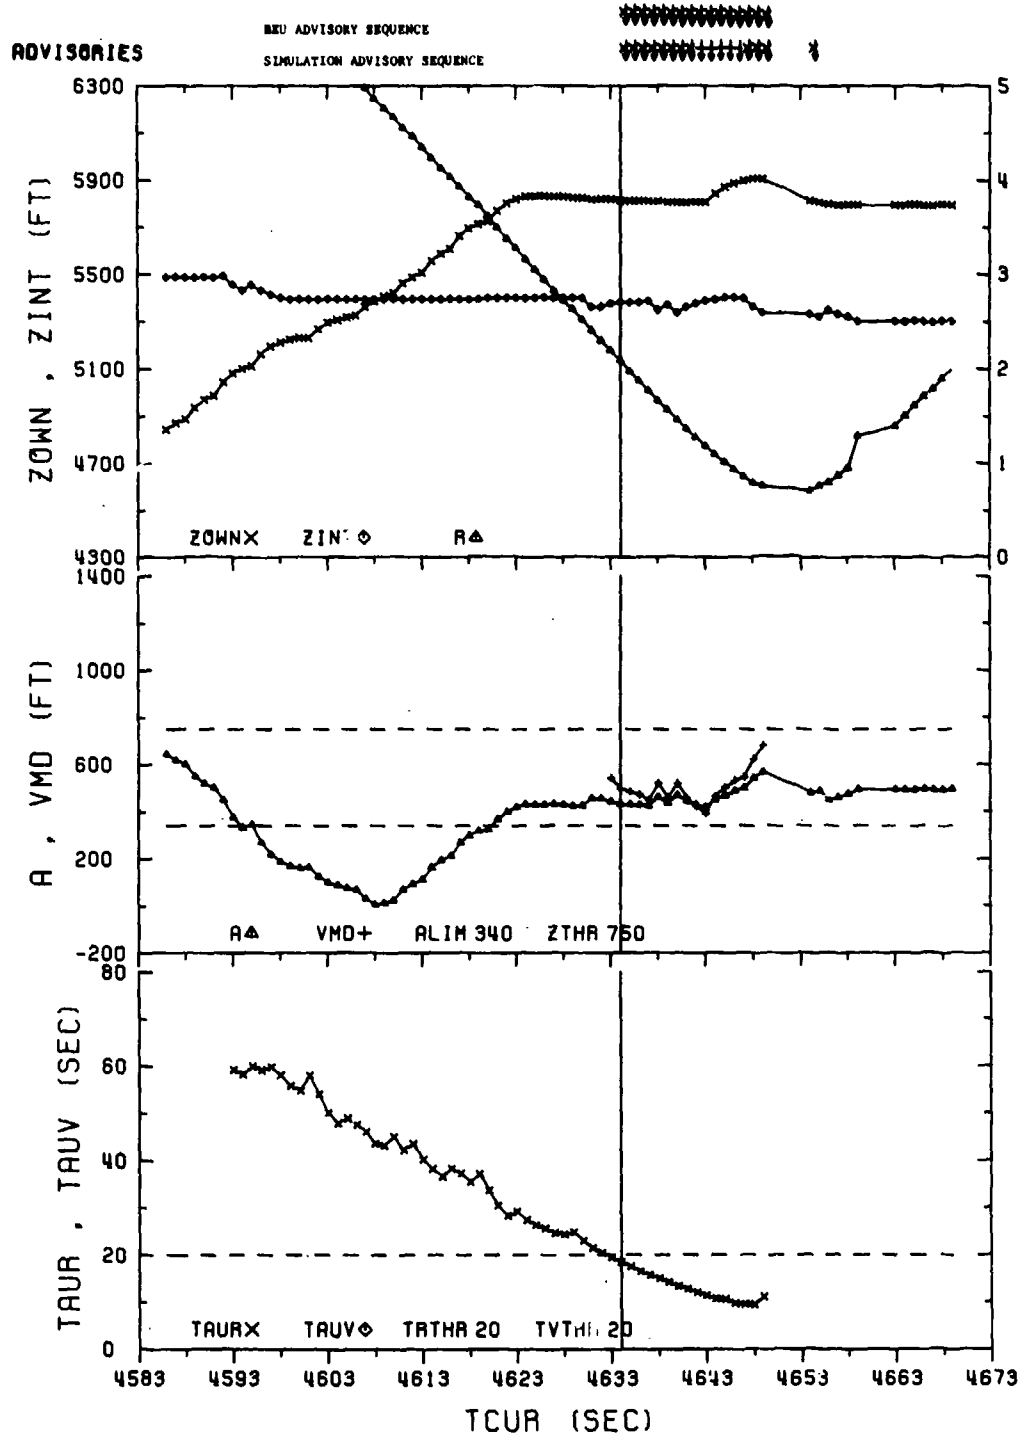
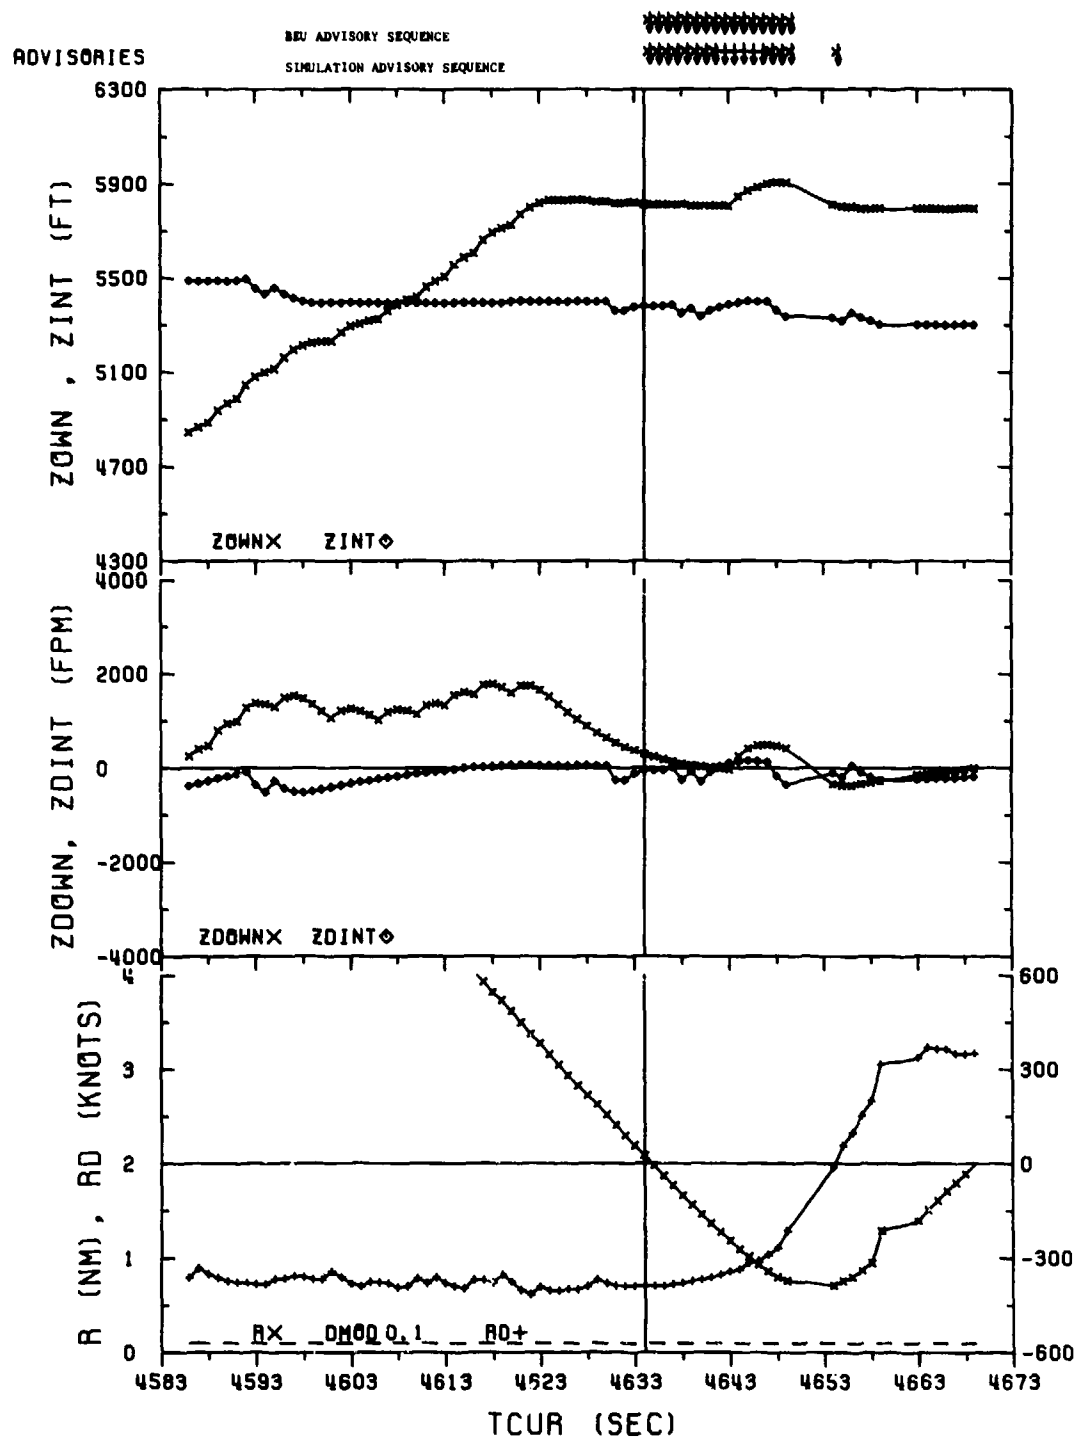
Fifteen seconds after the advisory ended for the previous encounter, another advisory was generated because of another aircraft (see Figures 4-20 and 4-21). The intruder was flying level 400 ft below the BCAS aircraft. Since the vertical separation was greater than ALIM, a negative advisory was given. Both aircraft remained essentially level. However, the tracked vertical rate of the BCAS aircraft (ZDOWN), when decaying after the level-off, overshot zero. When it became negative, it permitted the VSL test to be applied and a VSL was issued. When the rate again became positive, the VSL transitioned back to a negative.

FIGURE 4-20
SEPARATION, TAU PLOTS FOR ENCOUNTER 9 AT SALT LAKE CITY

FIGURE 4-21
SEPARATION, RATE PLOTS FOR ENCOUNTER 9 AT SALT LAKE CITY

The intent in the design of the BCAS logic was that the VSL test only be applied when own aircraft had a significant rate toward the intruder. Tracker residuals should not be permitted to cause transitioning into and out of the VSL logic. The transitions

occurring in this encounter do not reflect significant changes in the physical situation. The BCAS logic has since been modified so that the VSL test is only applied if own aircraft has a significant rate toward the intruder. This modification is included in Reference 3.

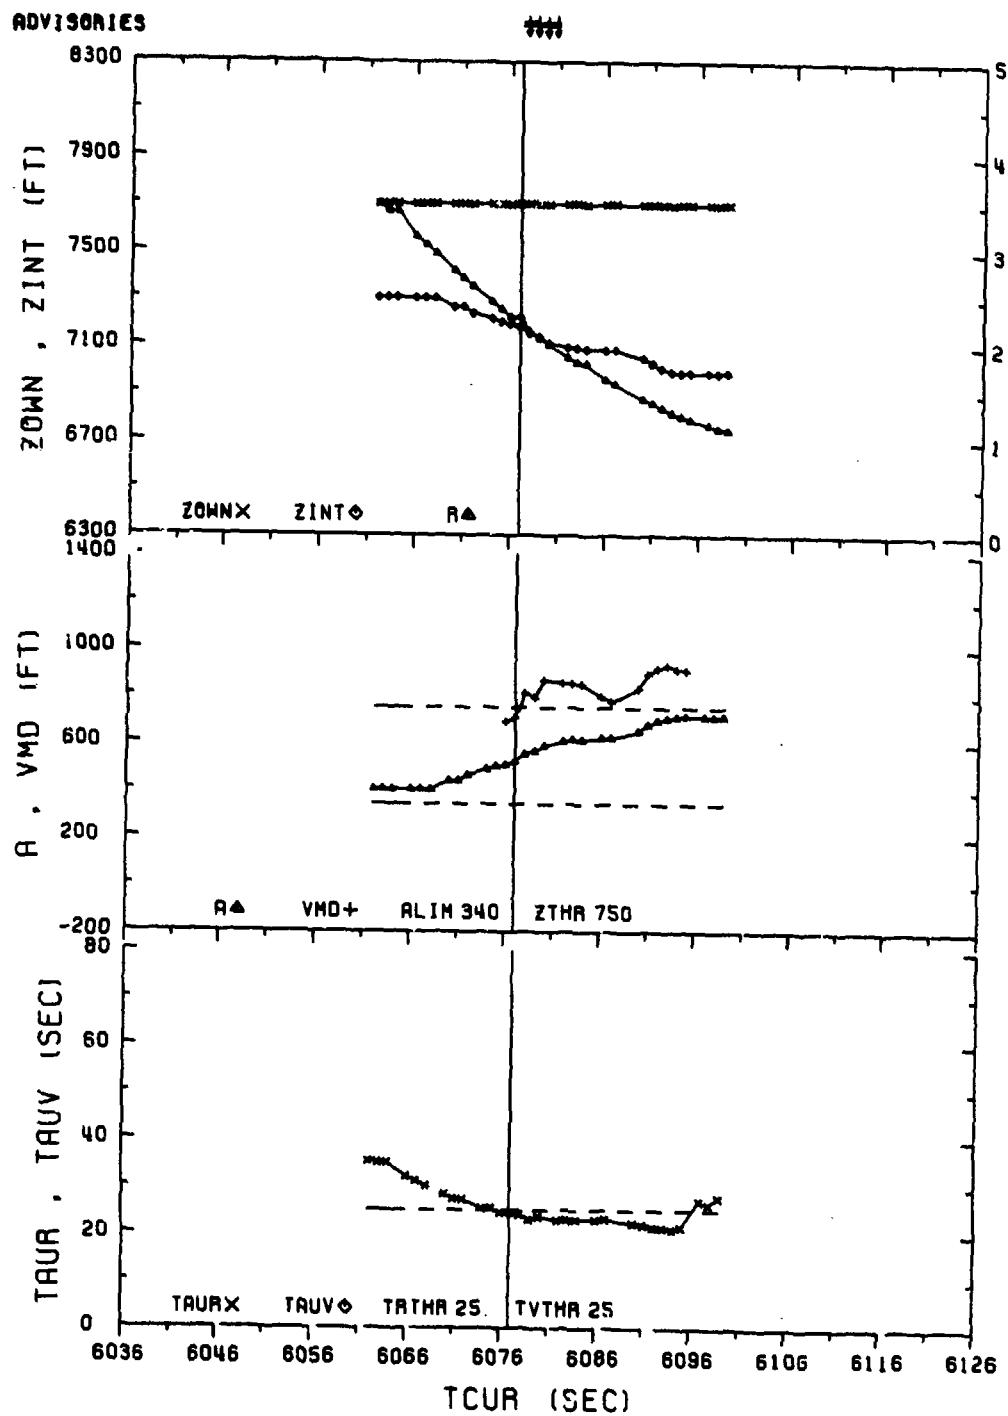
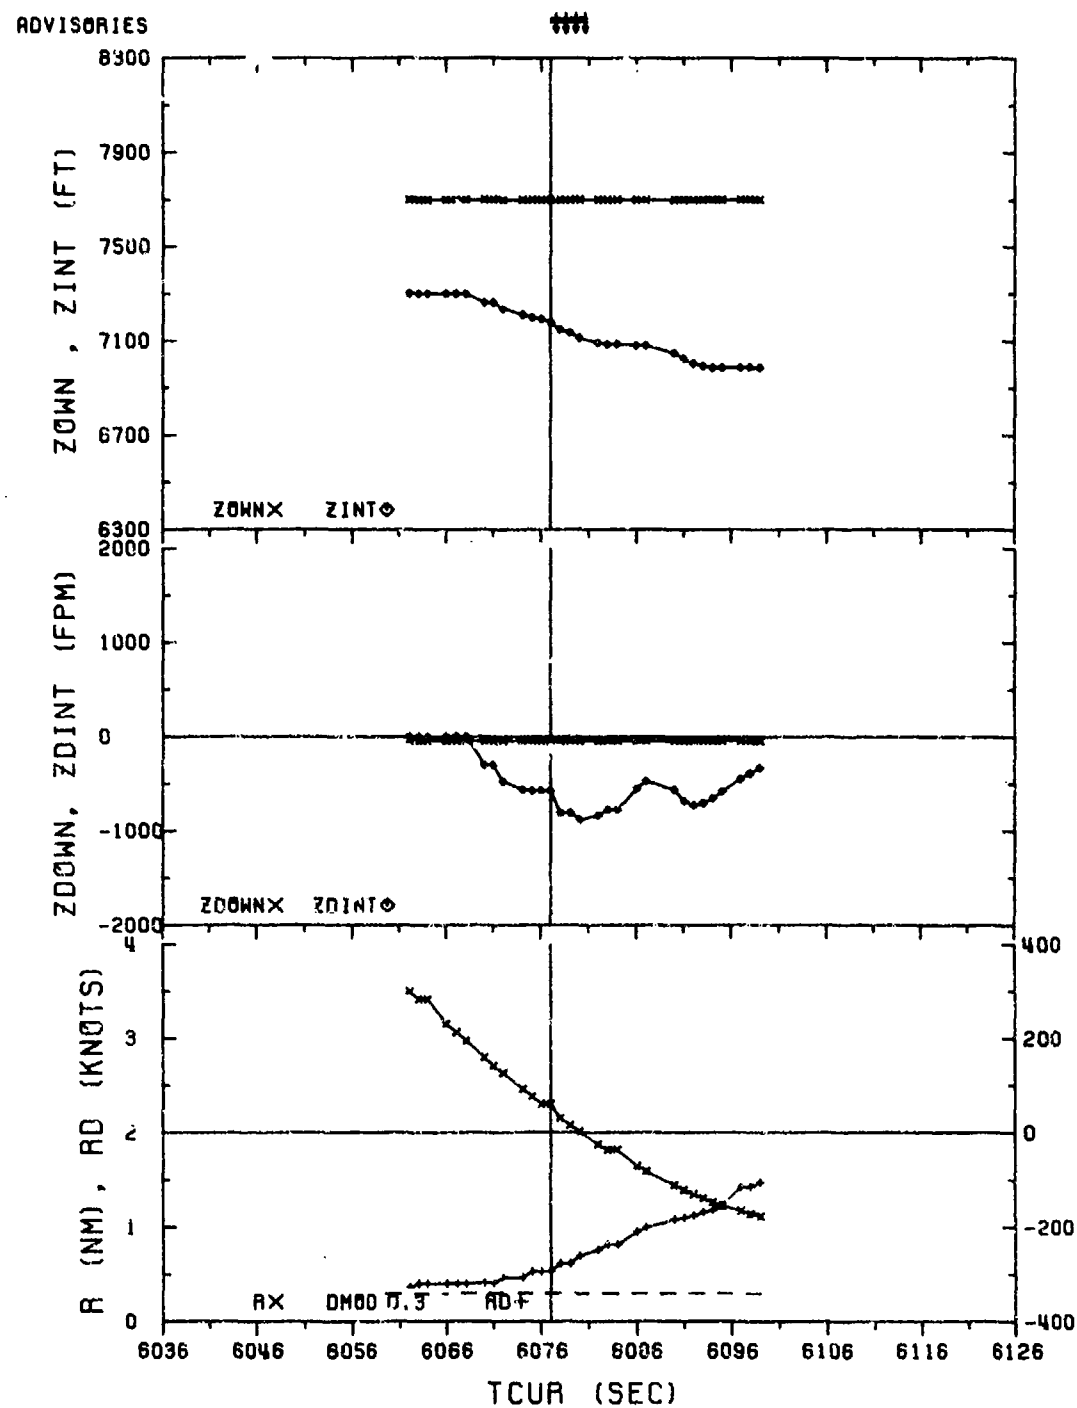
In this encounter, the BCAS aircraft was actually level, so that a negative advisory, don't descend, would have been sufficient and would not have been disruptive. The logic modification discussed in paragraph 4.4.2 would have caused a negative advisory to be issued in this encounter, rather than the VSL.

FIGURE 4-22
SEPARATION, TAU PLOTS FOR ENCOUNTER 10 AT LOS ANGELES

FIGURE 4-23
SEPARATION, RATE PLOTS FOR ENCOUNTER 10 AT LOS ANGELES

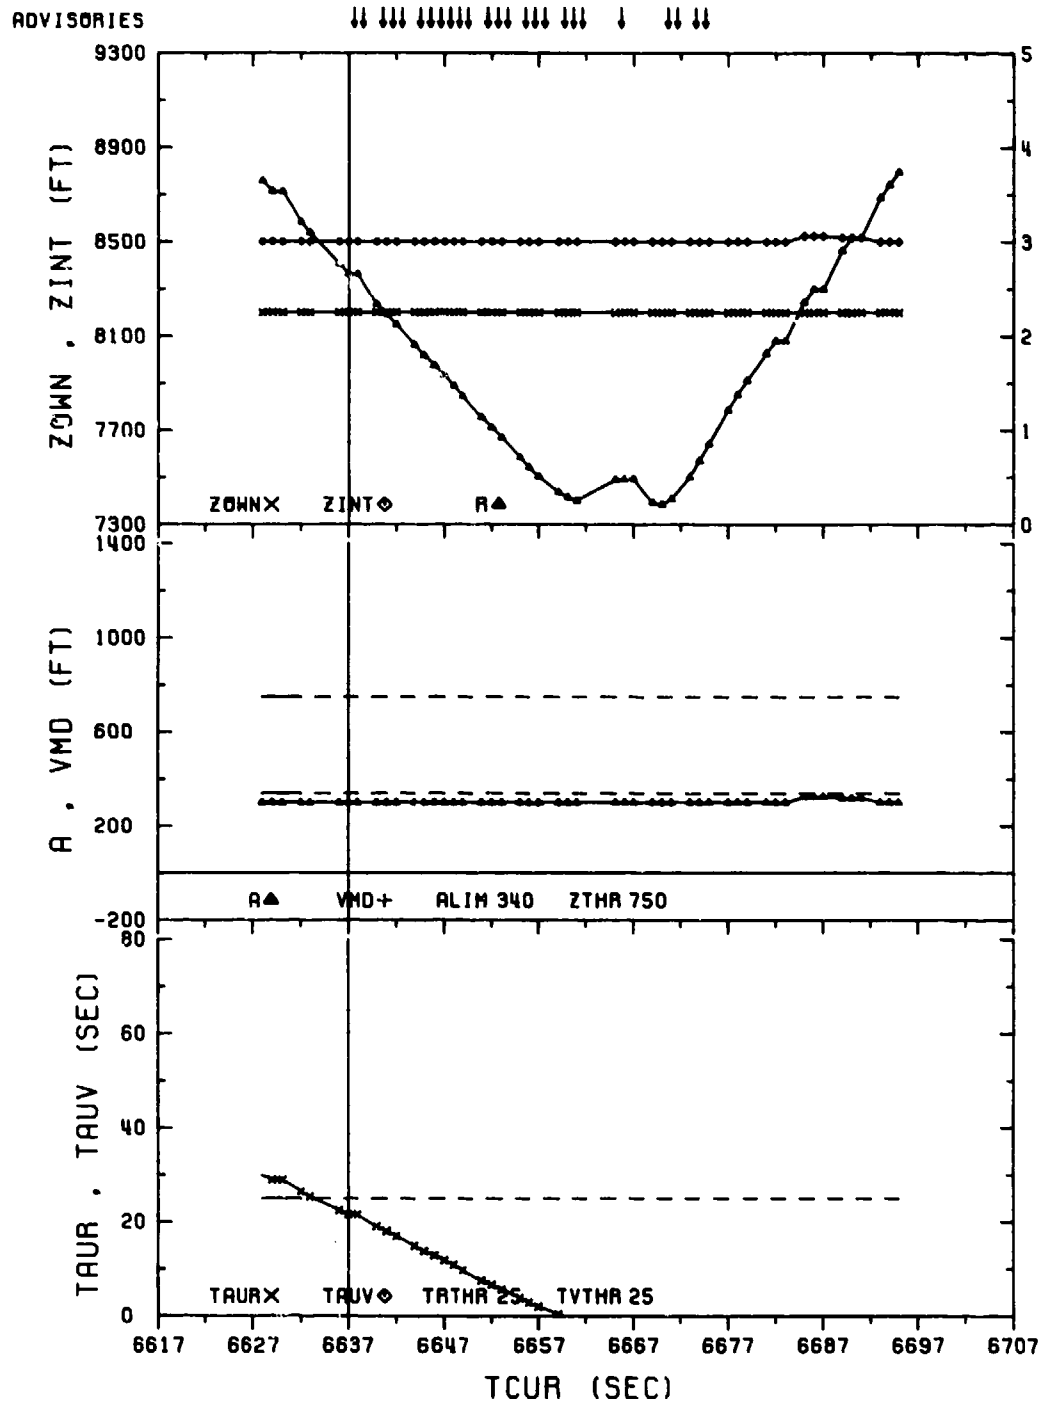
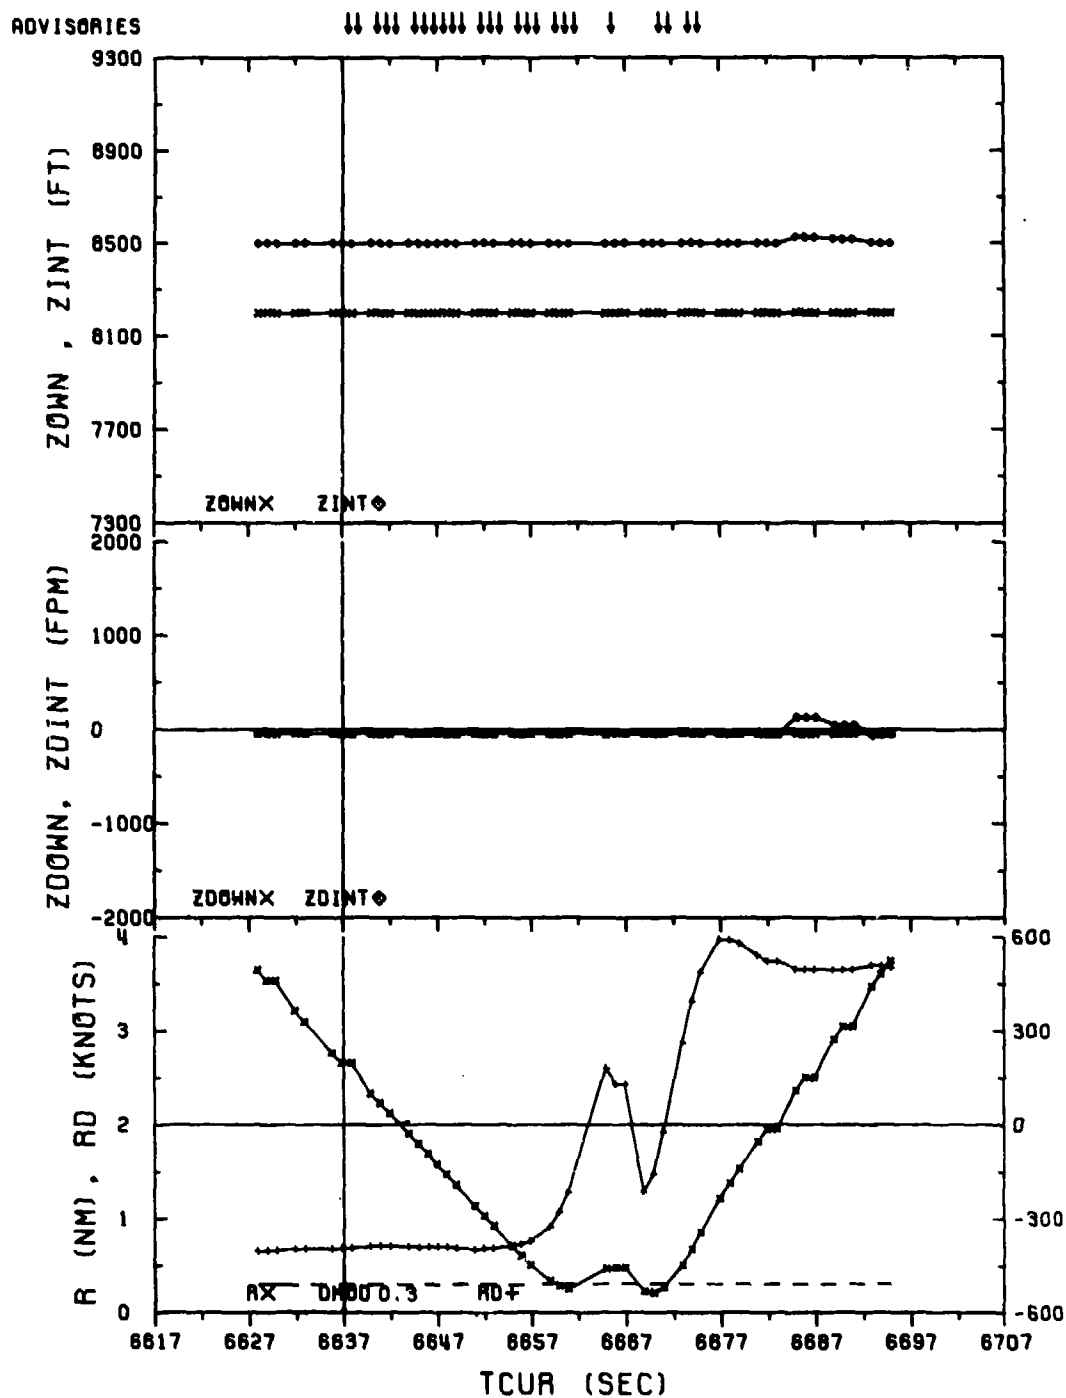
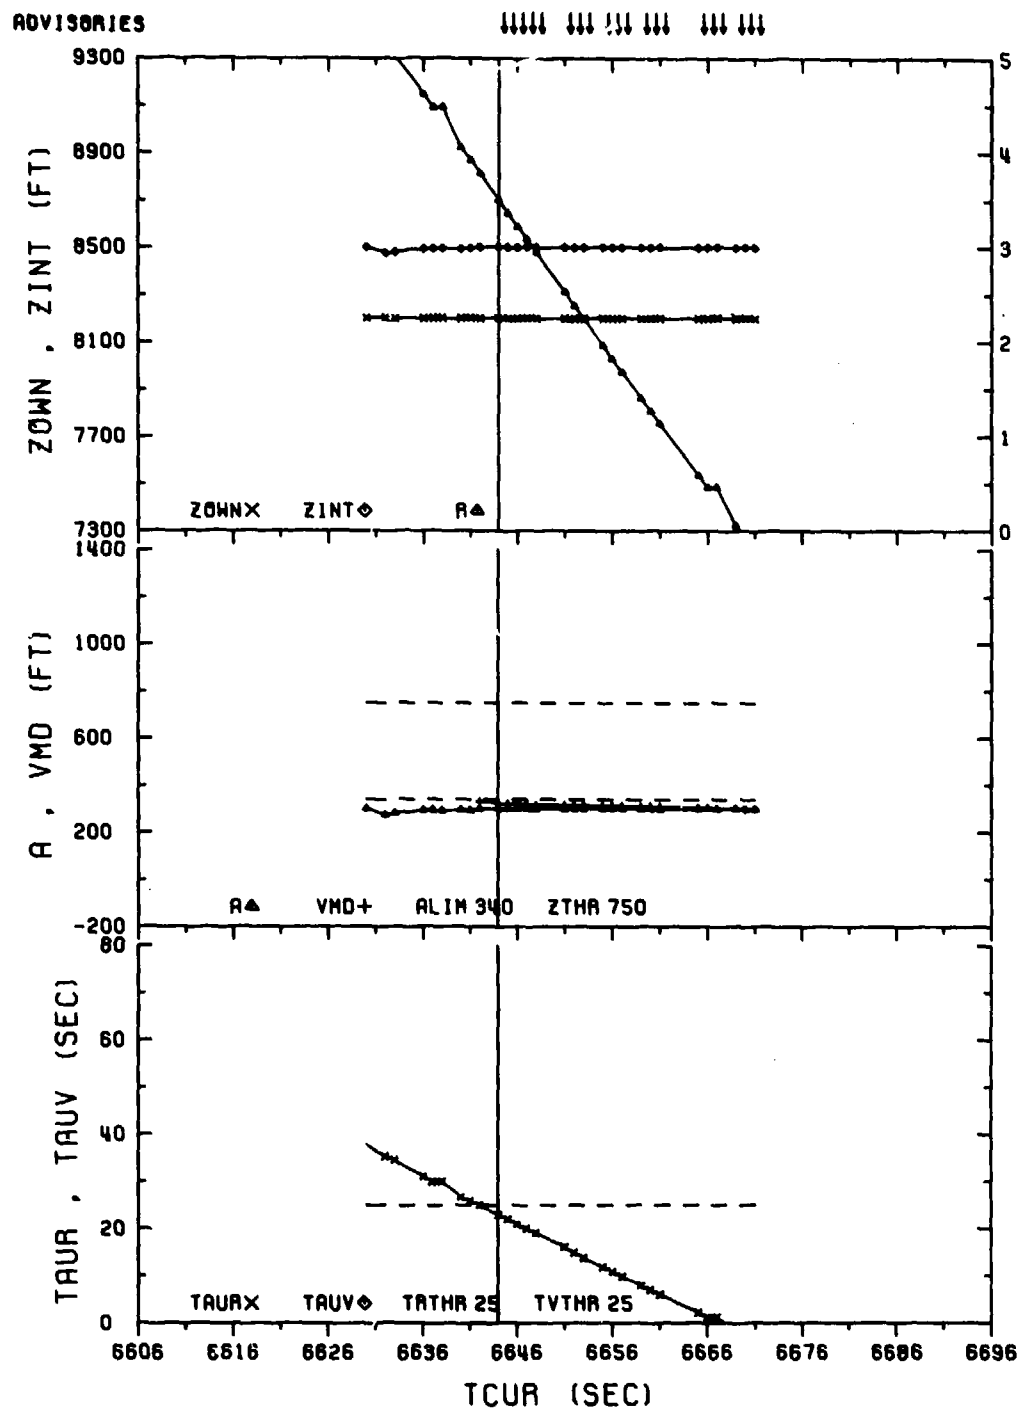
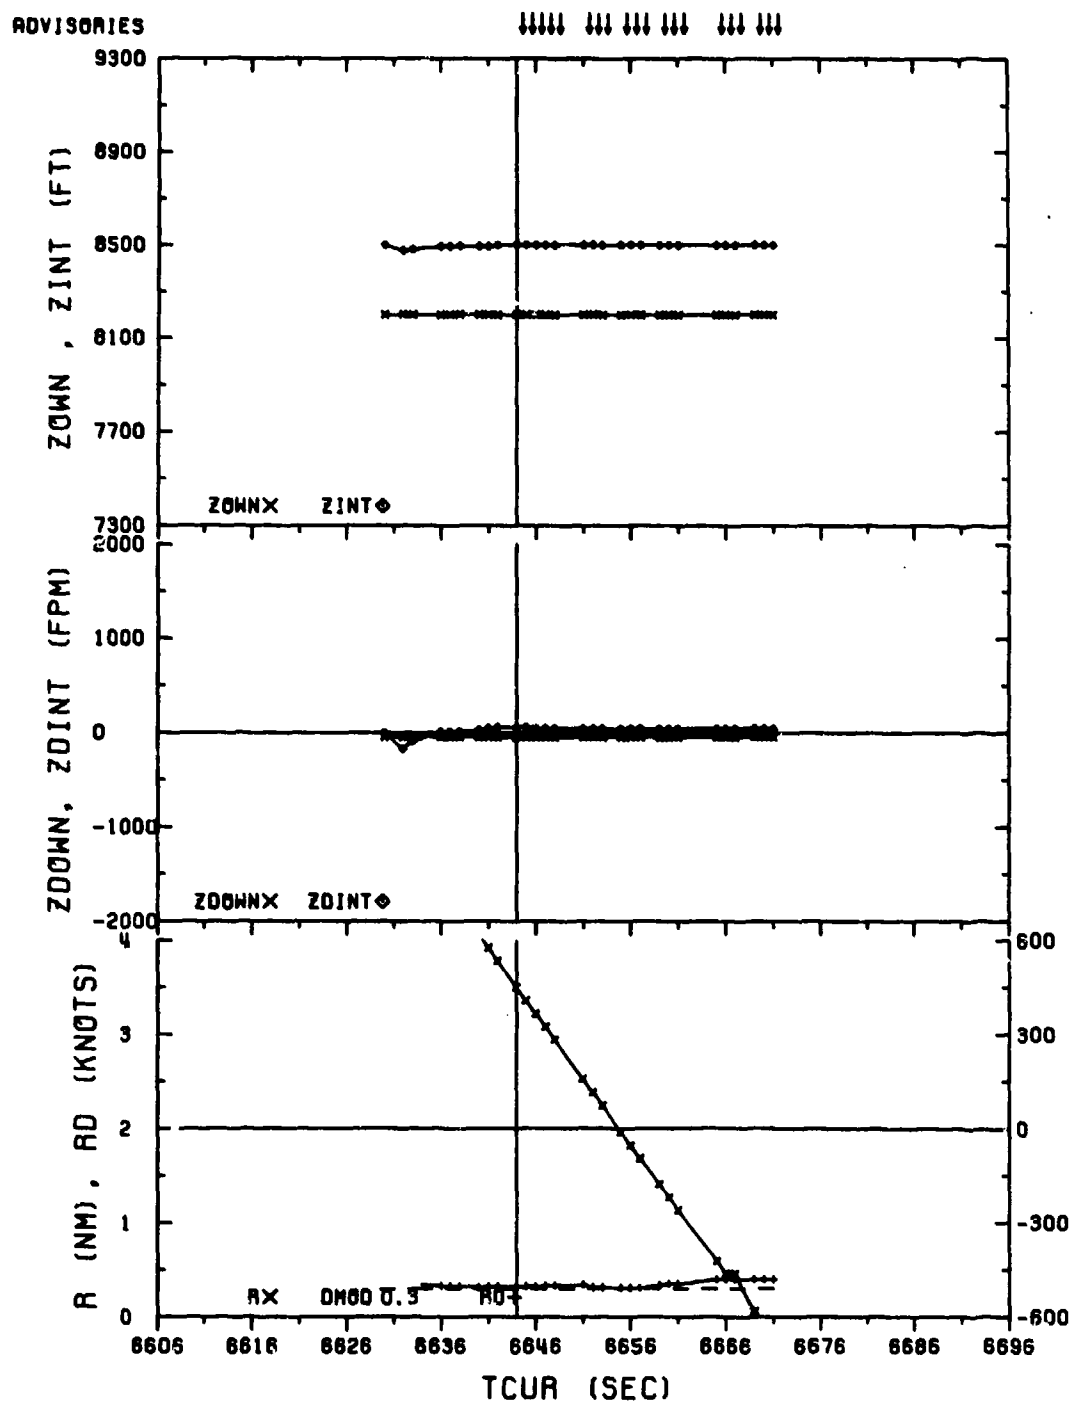
FIGURE 4-26
SEPARATION, TAU PLOTS FOR ENCOUNTER 12 AT LOS ANGELES

FIGURE 4-27
SEPARATION, RATE PLOTS FOR ENCOUNTER 12 AT LOS ANGELES

FIGURE 4-28
SEPARATION, TAU PLOTS FOR PLANNED ENCOUNTER AT LOS ANGELES

FIGURE 4-29
SEPARATION, RATE PLOTS FOR PLANNED ENCOUNTER AT LOS ANGELES

The simulation did not have the capability to process multiple intruders simultaneously. Therefore, the plots in Figures 4-26 through 4-29 were generated for one intruder at a time. In Figure 4-30, the TAUR and range curves for the two intruders are drawn together on the same plot. While the two intruders had different closing speeds, it is evident that they both reached closest approach at nearly the same time. The surveillance data on both tracks was good.

One final observation about this encounter can be noted here. In Figures 4-27 and 4-29 it appears that the surveillance system swapped tracks when the two tracks crossed in range. The unplanned encounter had a closing speed of about 400 kn prior to closest approach. (See the RD curve on Figure 4-27). After closest approach, it had a speed of about 500 kn. The planned encounter had a closing speed of about 500 kn as can be seen from Figure 4-29. Figure 4-31 shows that both the BCAS aircraft and the Mooney aircraft continue more or less straight after the closest approach, so that the RD curve on the separating side should have nearly the same speed as on the closing side of closest approach. The fact that the speed changed by 100 kn suggests that the surveillance system did swap tracks. In addition, the track for the planned encounter dropped after closest approach (see the R curve in Figure 4-28). Work is going on to study and correct this apparent deficiency in the surveillance system.

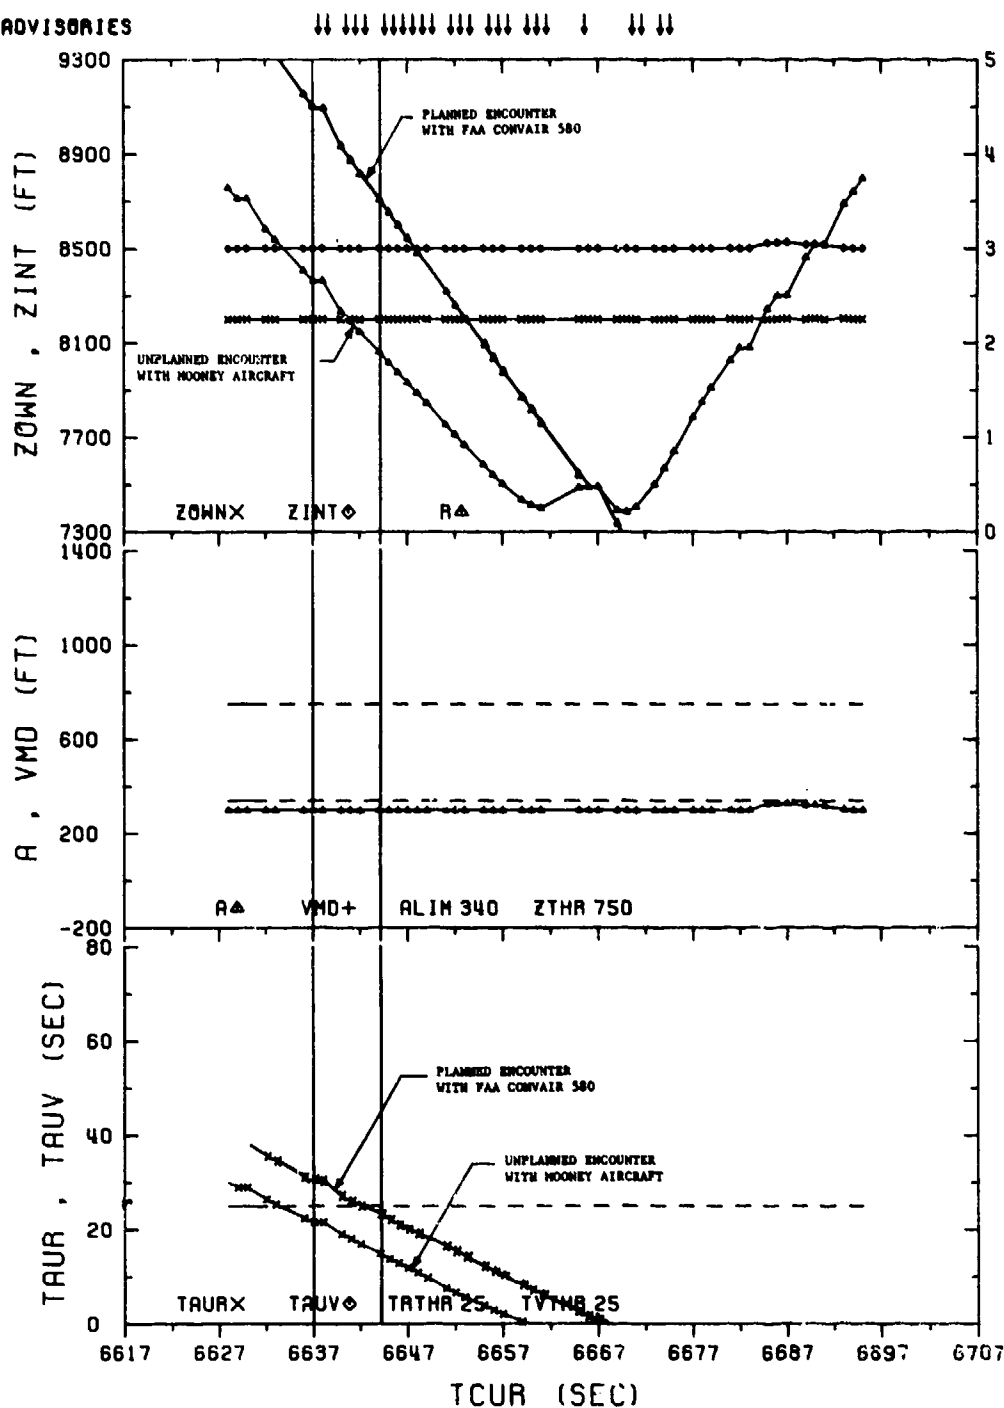
FIGURE 4-30
SEPARATION, TAU PLOTS FOR
MULTIPLE INTRUDER ENCOUNTER AT LOS ANGELES

An ARTS plot of this multi-aircraft encounter is presented in Figure 4-31. The Mooney aircraft was squawking a beacon code of 1200 and was at 8500 ft (an appropriate VFR cruising altitude) tracking to the Seal Beach VOR. The two FAA aircraft were using the Seal Beach VOR as an aid to setting up the planned encounters, and were making East-West passes over the VOR. The capital letters indicate the positions of the aircraft at the same time. The three aircraft arrived at the VOR at very nearly the same time. At this time there is much data missing from the radar plot due to synchronous garble between the three aircrafts' transponders. The superiority of the BCAS surveillance in this situation is quite evident when Figure 4-31 is compared with Figure 4-30.

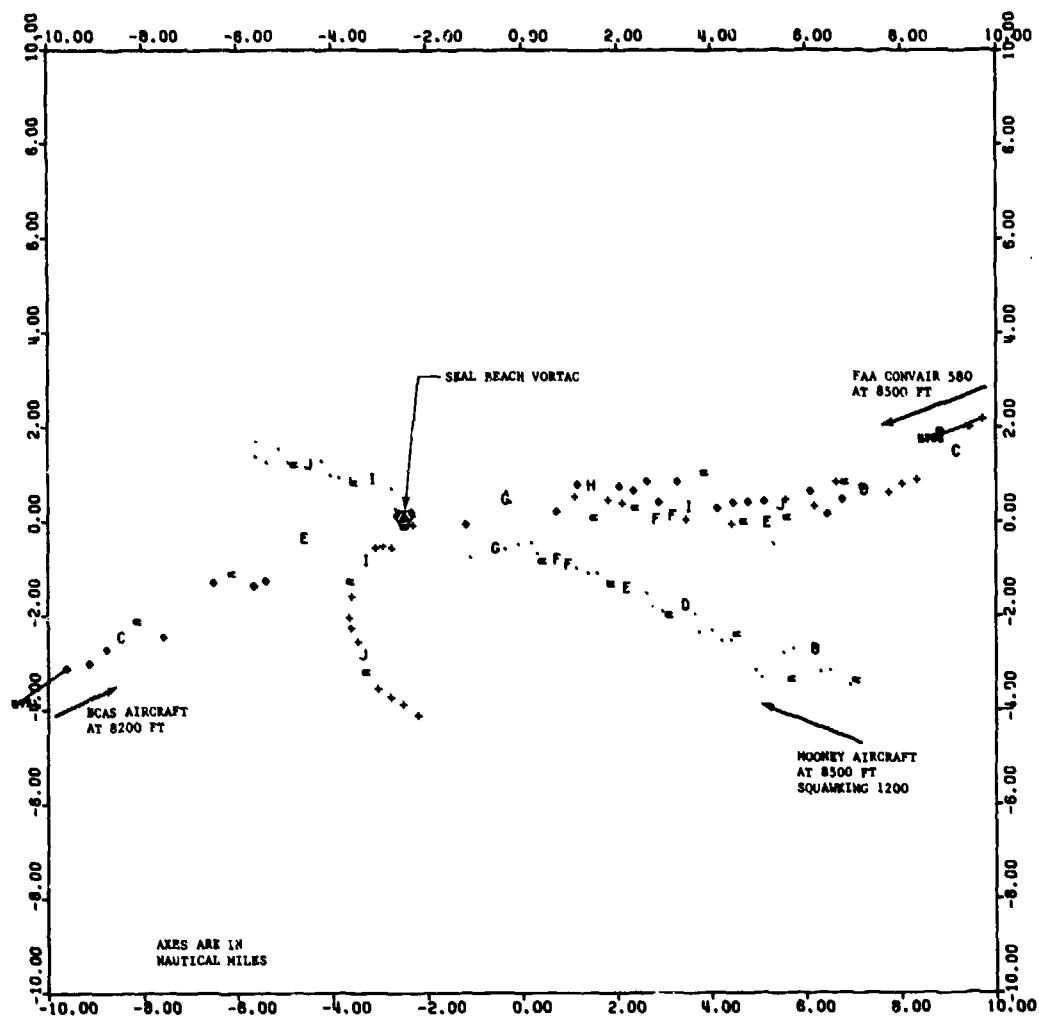
FIGURE 4-31
ARTS PLOT OF MULTIPLE INTRUDER ENCOUNTER AT LOS ANGELES

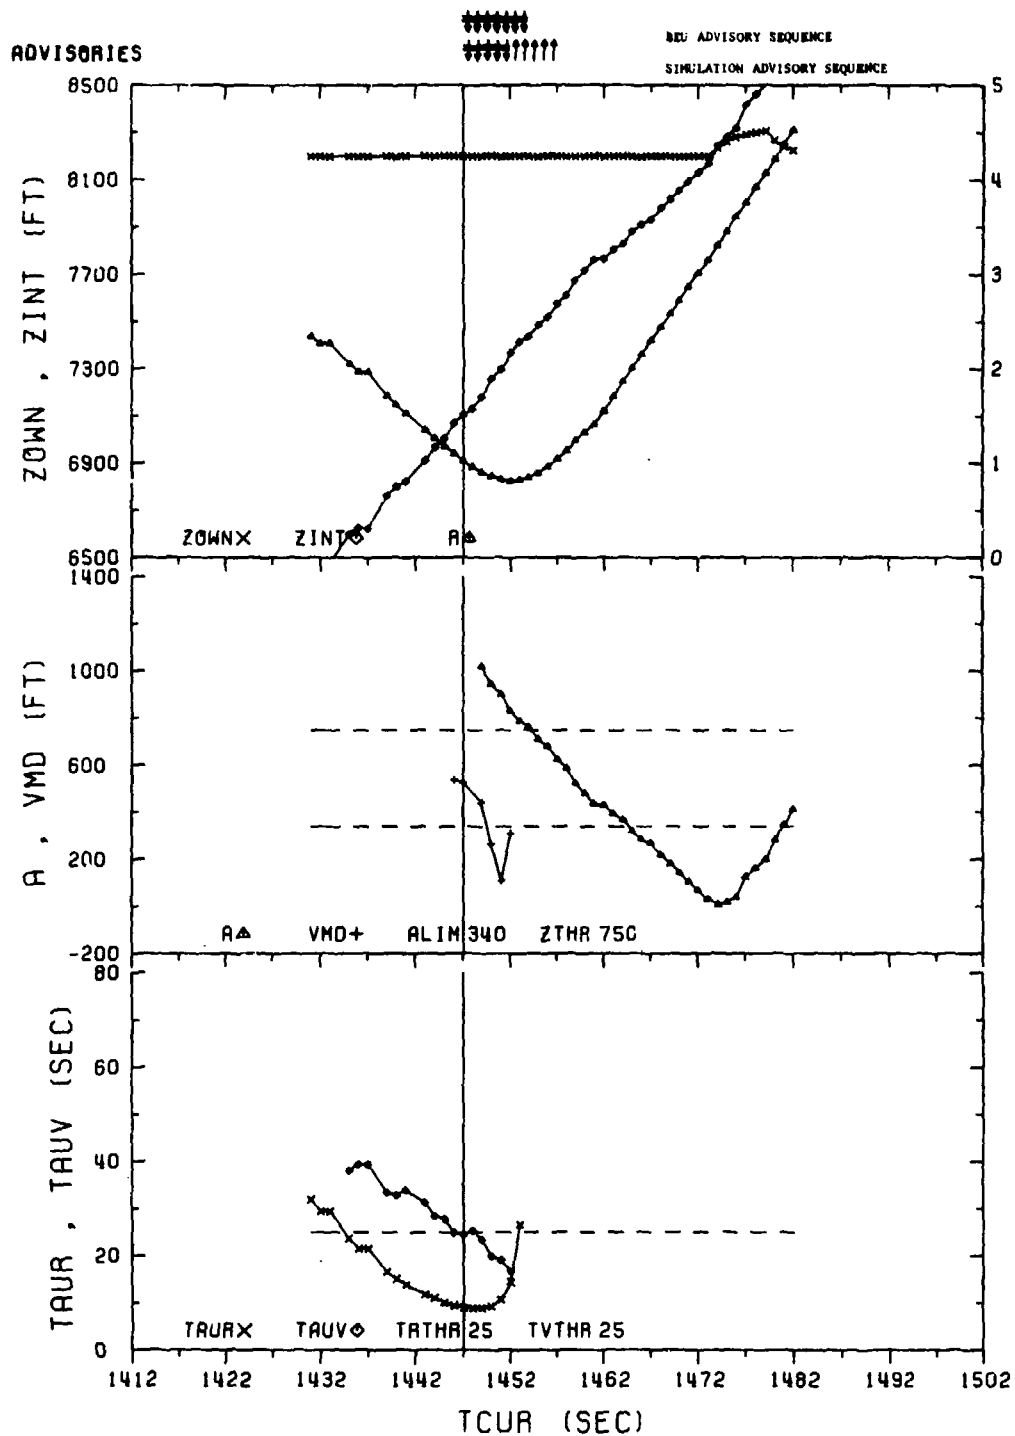
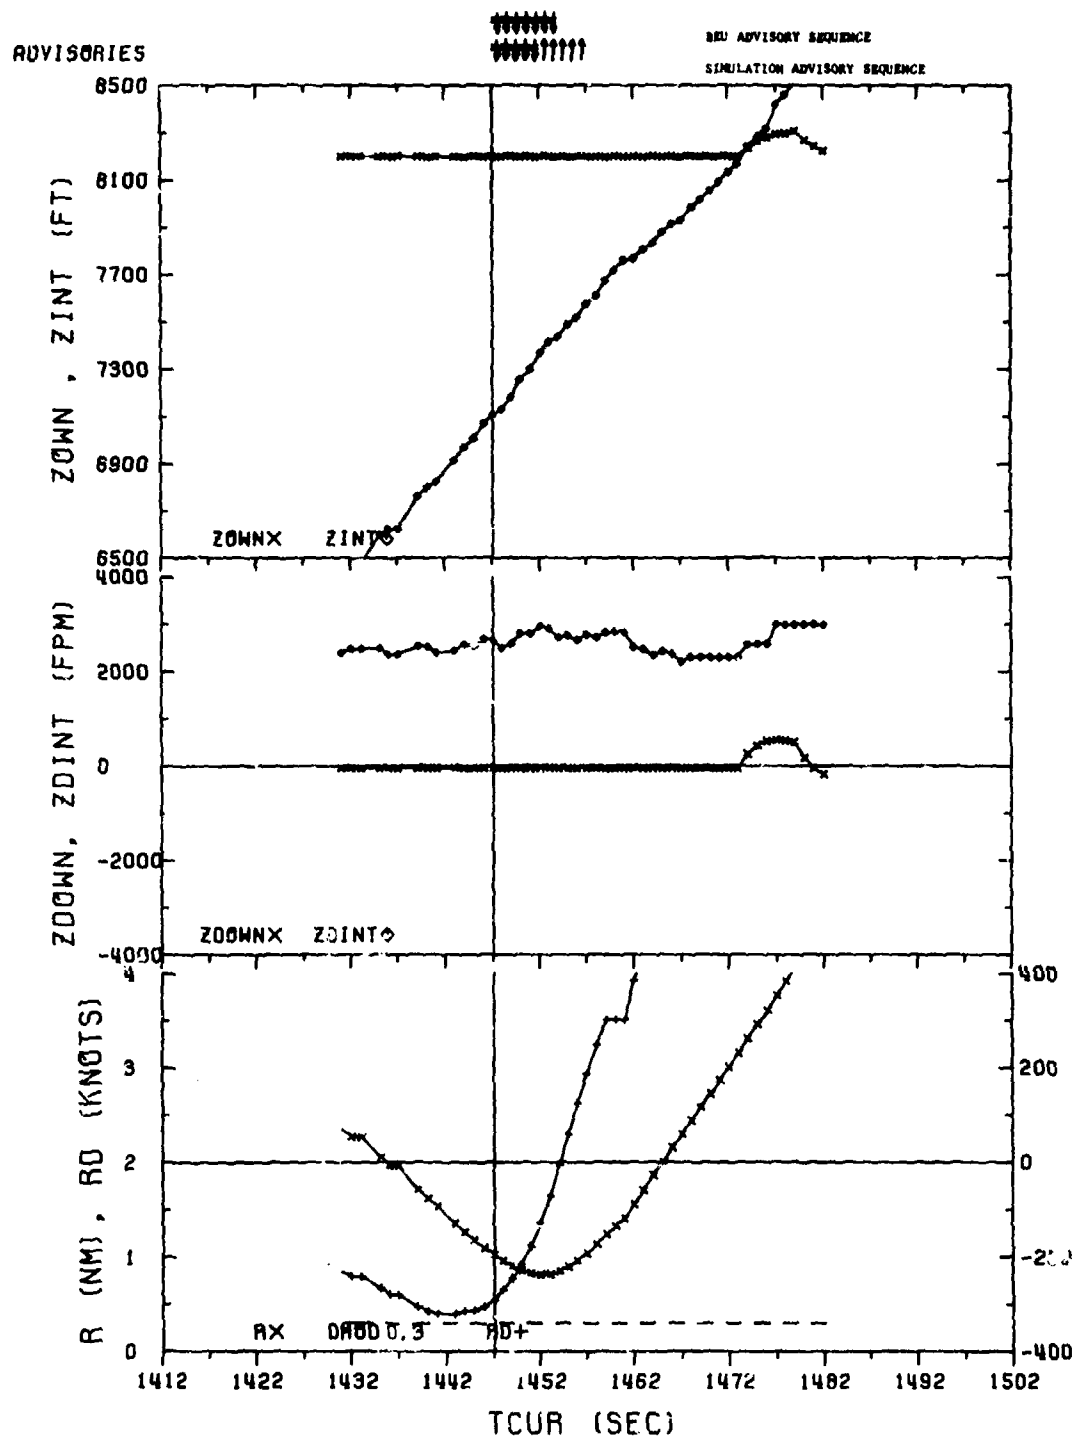
The BCAS simulation calculated a limit descent to 1000 fpm advisory and then a climb advisory, five seconds later, (see Figures 4-32 and 4-33). On the next cycle the aircraft were declared not in conflict. The climb advisory stayed up for another four seconds because of the five second hold on advisories.

FIGURE 4-32
SEPARATION, TAU PLOTS FOR ENCOUNTER 13 AT LOS ANGELES

FIGURE 4-33
SEPARATION, RATE PLOTS FOR ENCOUNTER 13 AT LOS ANGELES
